REPORT OF INVESTIGATION

Surface Nonmetal Mine  
(Crushed Stone)

Fatal Machinery Accident  
February 13, 2006

Pyramid Materials  
Pyramid Materials – Div / Haines & Kibblehouse Inc  
Media, Delaware County, Pennsylvania  
Mine I.D. No. 36-08977

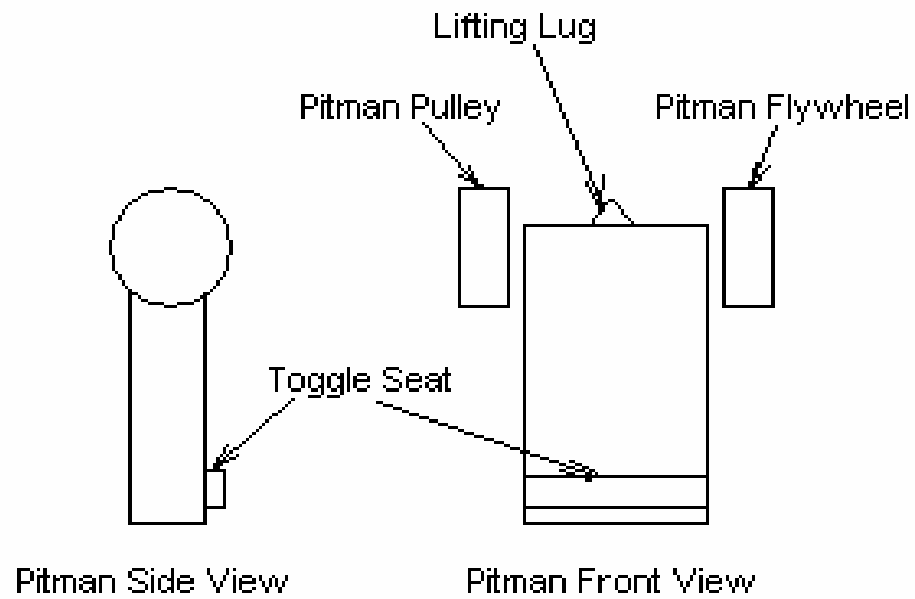
## APPENDIX B

The pitman assembly or jaw was the component being picked during the accident. The jaw was driven through a multi grooved v-belt pulley attached to one end of a large eccentric shaft with a flywheel attached to the other end of the shaft. The jaw was supported by bearings located on this eccentric shaft. The pitman assembly body was constructed of heavy cast metal with an assembly weight of 7,100 pounds. A single cast lifting lug was positioned on top of the pitman assembly. The placement of this lifting lug permitted a single point balanced load during lifting of the pitman assembly. (Appendix B describes the pitman assembly)

The following illustration describes the pitman assembly (not to scale):

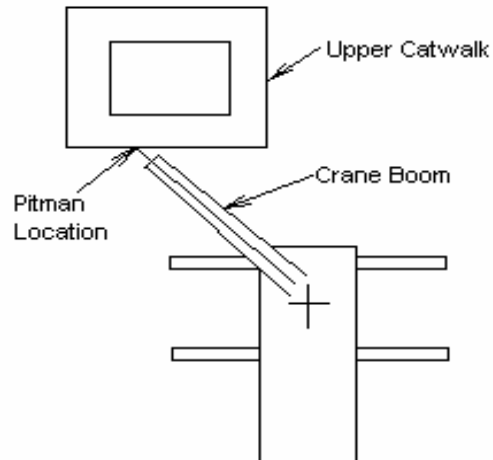
## APPENDIX C

The crane placement was limited due to the configuration of the surrounding structures. The crane carrier was backed into the location. The crane placement dictated that the lift would have to be done by picking the pitman assembly from a lower level catwalk of the crusher unit over the left rear corner of the crane and swinging the boom to the right over the rear of the crane to lower the pitman assembly to the ground. The configuration of an upper catwalk located on a screen section of the crusher unit prevented a straight and unrestricted vertical pick and caused the lifting line to scrape against the upper catwalk.

This lifting configuration was not an acceptable practice according to the crane manufacturer. The crane's operating manual clearly stated the following "No attempt shall be made to drag a load horizontally on the ground in any direction." When the crane picked the pitman assembly from the mounting location, an external force was exerted onto the pitman when it slid up and out of the mount. This type of external force is similar to using the hoist rope to drag an object on the ground.

The following illustration indicates the relative position of the crane to the pitman assembly picking position (not to scale):

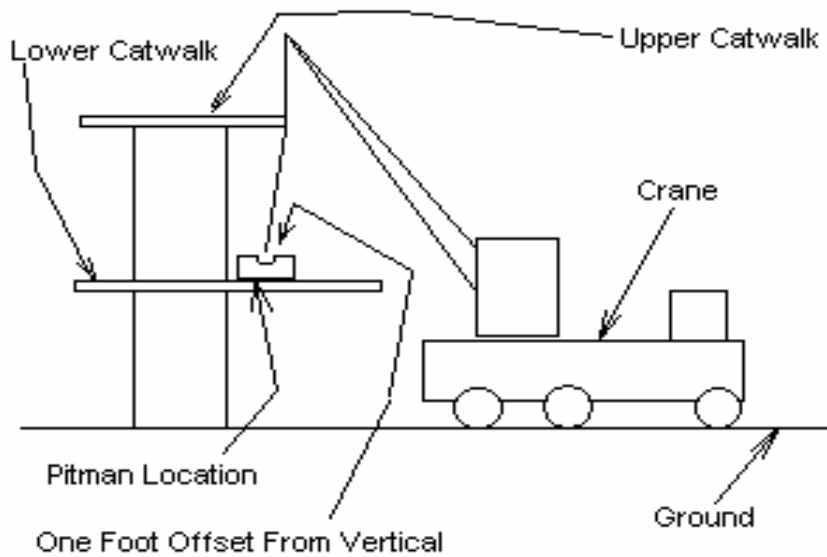
**Root Cause:** A risk assessment to determine all possible hazards and to establish safe work procedures was not conducted prior to performing the task. No procedures were in place to ensure that persons were clear of suspended loads. The location of the pitman assembly in relation to the upper level screening section catwalk on the crusher prevented a straight, perpendicular, and unrestricted crane pick causing the lifting line to scrape against the upper catwalk.

The following illustration indicates the relative position of the crane/pitman assembly/upper catwalk picking position (not to scale):

The order was terminated on February 15, 2006. Conditions that contributed to the accident have been corrected and normal mining operations can resume. The mine operator has submitted a written plan to MSHA showing the removal of the overhead walkway which would provide the space needed to make a vertical pick with a crane, without obstruction, so all repairs can be performed safely.
